A Risk Reduction Presentation: Floodplain Management Series  
FEMA Region VII – Kansas City, MO

# The NFIP's Substantial Improvement/Damage requirements

**September 13, 2017**

**KEMA Conference – Topeka, KS**

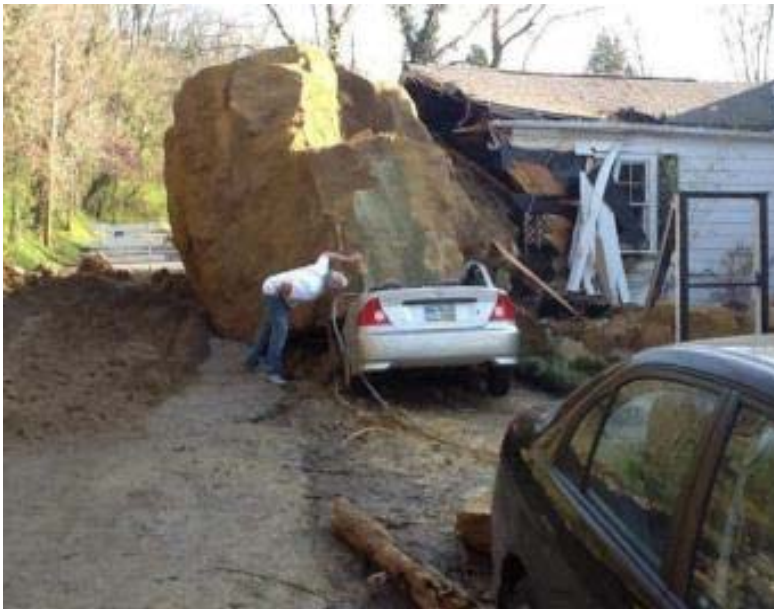
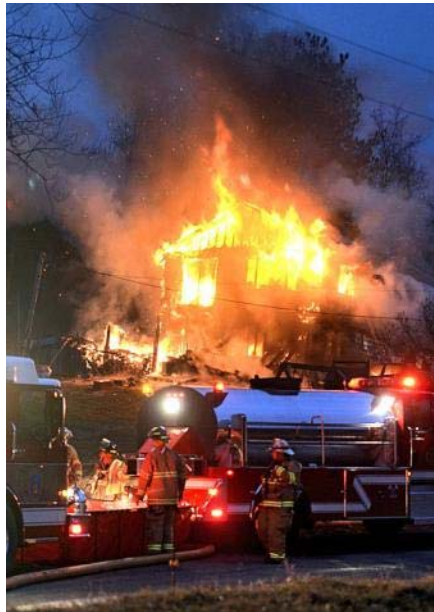
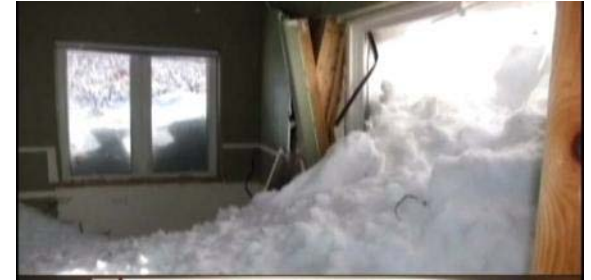
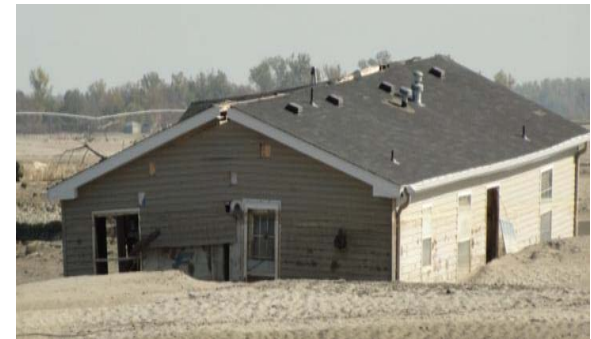
- Damage of any origin sustained by a structure whereby the cost of restoring the structure to its before damage condition would equal or exceed 50 percent of the market value of the structure before the damage occurred.

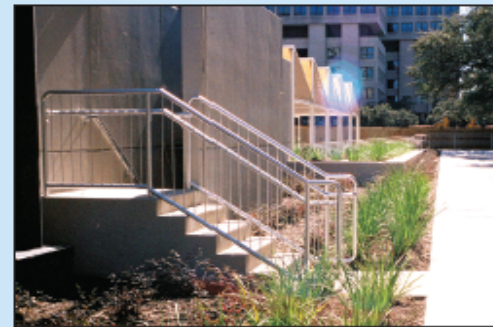
Figure 3-25. Three sets of stairs that provide building egress during the design flood event, but still allow normal use of the building (source: Walter P. Moore)

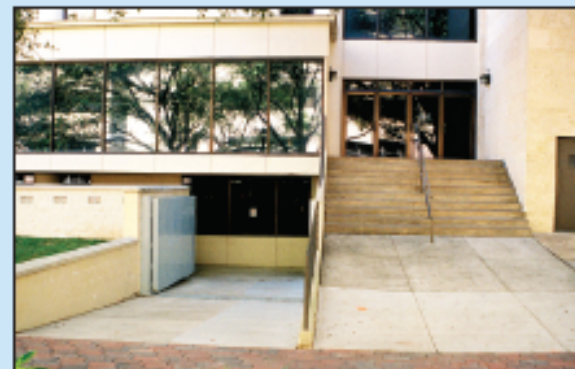
Figure 3-23. Flood doors incorporated into the existing building façade (source: Walter P. Moore)

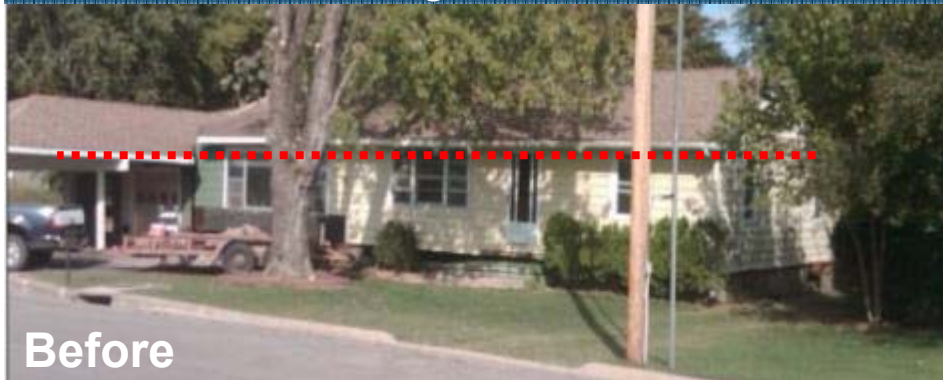
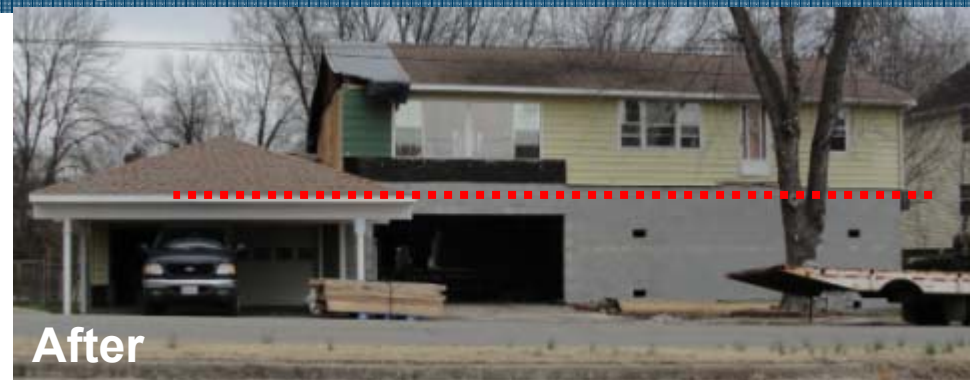
**Branson, Mo.: Substantially damaged Pre-FIRM structure – Date of Damage. April 2011 w/1 foot of flood water. Elevated in 2012 to 1 foot above BFE, using ICC.**

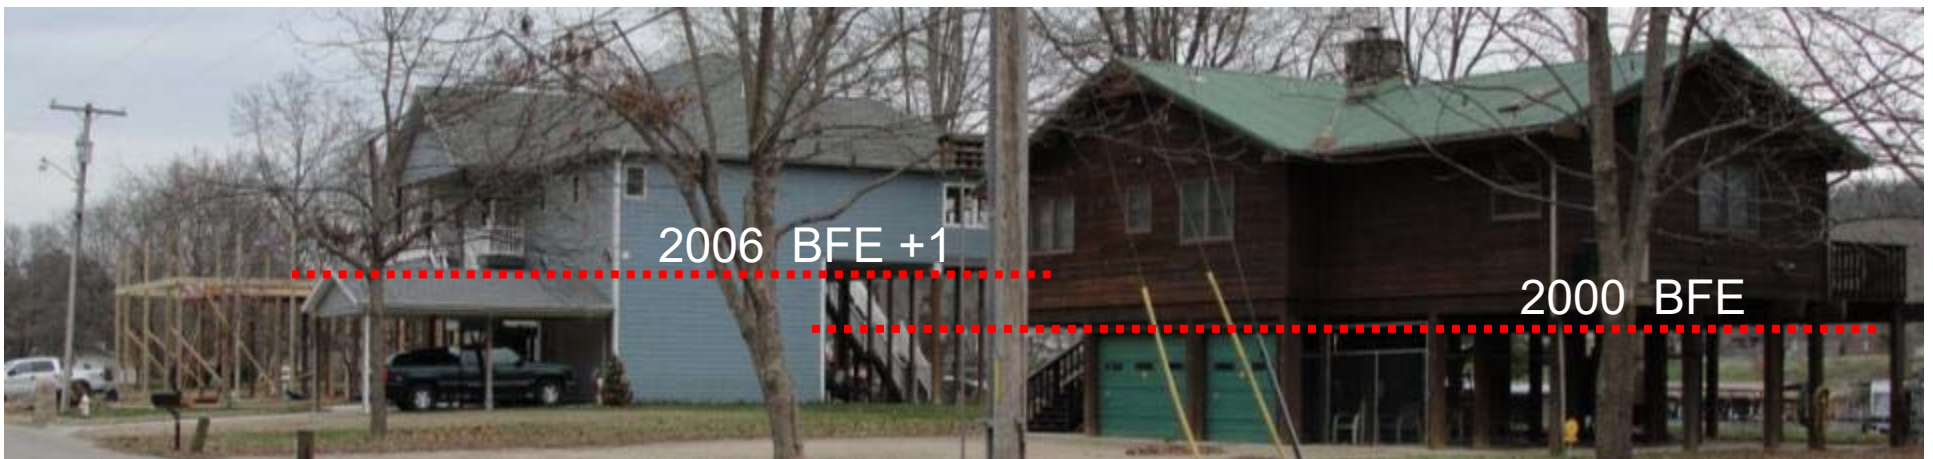
**Branson, Mo. : Structures demonstrating how the BFE has changed over time and implementation of the Substantial Damage requirement.**

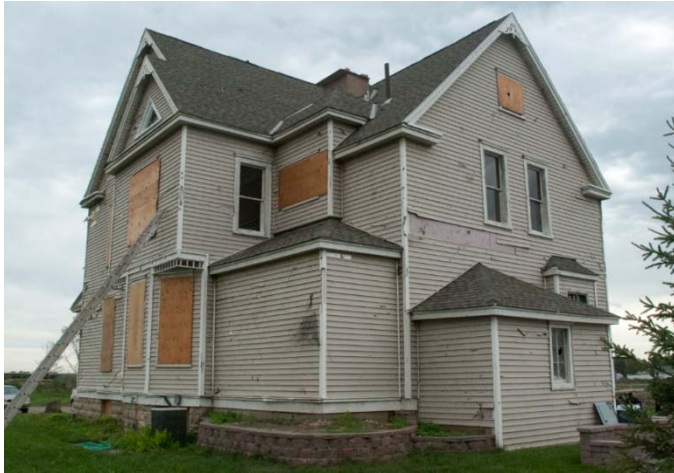
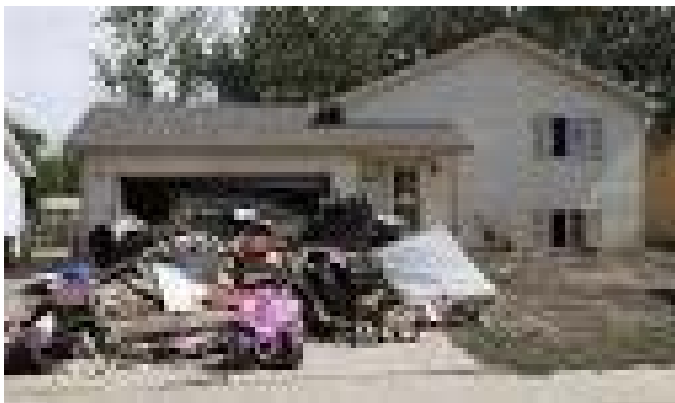
# 12 Elements of Residential SDE Inspection

Item	% Damaged	Element %	Item Cost	Damage Values
Foundation (SF only)				
Superstructure				
Roof Covering				
Exterior Finish				
Interior Finish				
Doors and Windows				
Cabinets and Countertops				
Flood Finish				
Plumbing				
Electrical				
Appliances				
HVAC				
Skirting / Forms Piers (MH only)

Roof Covering		0-25%	25-50%	50-75%	Over 75%
Description	<p>Roofing includes a lightweight composition shingle, tile roofs, metal roofs, or a built-up roof with gravel or rock cover material. Roofing does not include structural framing members such as rafters or prefabricated trusses that support the roof deck. The roof sheathing and flashing is included in this section.</p>	<p>Minor wind damage to the roof coverings.</p> <p>Main surface areas are unaffected.</p> <p>Flashings are intact.</p> <p>No damages to the roof sheathing.</p>	<p>Some damaged areas of the roof from high-winds or damages from debris.</p> <p>Some sections of the roof covering are missing or loose.</p> <p>Some damages to the flashings.</p> <p>Minimal damage to the roof sheathing.</p>	<p>Significant damaged areas of the roof from high winds or damages from debris.</p> <p>Significant sections of the roof covering are missing or loose.</p> <p>Damages to the flashings allow some water infiltration at joints and roof penetrations.</p> <p>Significant damage to the roof sheathing - some areas of the sheathing will need replacement.</p>	<p>Large damaged areas of the roof from high winds or damages from debris.</p> <p>Major sections of the roof covering are missing or loose.</p> <p>Damages to the flashings allow significant water infiltration at joints and roof penetrations.</p> <p>Major damage to the roof sheathing - most of the roof sheathing will need replacement.</p>

Threshold Markers	<p>Roof shingles or tiles mostly intact. Some minor damage to roof shingles - some torn or loose shingles in limited areas.</p>	<p>Some areas where the roof shingles were damaged by high winds. Several small areas of exposed roof sheathing as a result of missing/damaged shingles.</p>	<p>Some areas where the roof shingles were damaged by high winds. Several small areas of exposed roof sheathing as a result of missing/damaged shingles. Some damage to the roof covering and sheathing due to debris falling or penetrating the roof assembly.</p>	<p>Major areas of the roof where the shingles/tile are missing, allowing rainwater to freely enter the house below. Significant damage to roof covering and roof sheathing from strong winds or windborne debris penetrating the roof assembly.</p>
	<p>Special Considerations for Coastal/High Velocity Floods</p>	<p>Coastal areas have higher wind conditions requiring additional roof covering requirements.</p> <p>Damages to these roof coverings would indicate a higher percent of damages, because they are designed to resist higher wind conditions.</p> <p>Damages to the roofing are more likely during high-wind conditions due to the loss of protection from missing roof coverings and water infiltration. This will increase the percent of damages.</p>

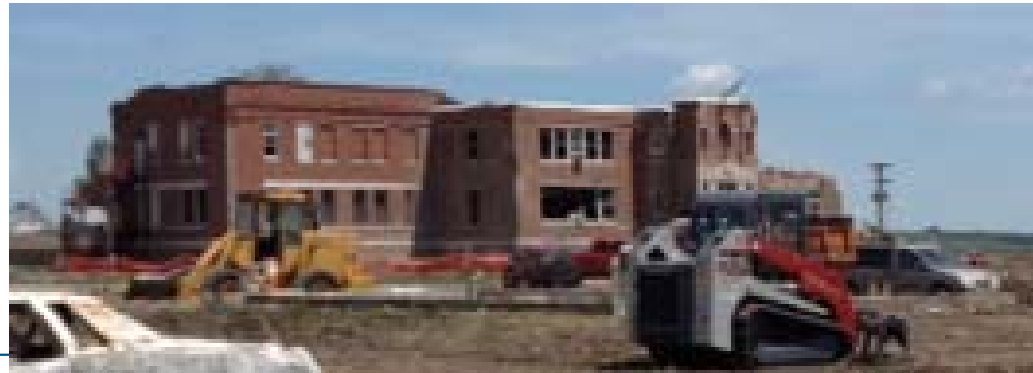
# 7 Elements Commercial SDE Inspection

- **Foundation**
- **Superstructure**
- **Roof Covering**
- **Plumbing**
- **Electrical**
- **Interiors**
- **HVAC**

<u>Item</u>	<u>% Damaged</u>	<u>Element %</u>	<u>Item Cost</u>	<u>Damage Values</u>
Foundation				
Superstructure				
Roof Covering				
Plumbing				
Electrical				
Interiors				
HVAC

Interiors		0-25%	25-50%	50-75%	Over 75%
Description	<p>Interiors include the partitions, interior doors, and surface finishes (for walls, floors, and ceilings). Materials include low-grade wood/plastic composites, soft woods, and hard woods. Finishes include paint, stain, or varnish.</p> <p>This item also covers any exterior and interior painted surfaces. This includes all interior painted surfaces, but not the building or repairs of the underlying surfaces. This also includes those exterior siding materials (and trim work) that need to be painted, but not those that have inherent coloring within the materials themselves (brick, stucco, EIFS).</p> <p><b>NOTE:</b> Non-residential structures with multiple stories will receive less damage to this element than single-story structures, as the majority of interior finish for multi-story structures will likely not be on the ground floor.</p>	<p><b>Threshold Markers</b></p> <p>Water level does not rise to the level of the first floor structure.</p> <p>The duration of the floodwaters is limited - less than 12 hours.</p>	<p>Water level rises just above the first floor level.</p> <p>The duration of the floodwaters is limited - less than 12 hours.</p>	<p>Water level is up to 3 feet above the first floor level.</p> <p>The duration of the floodwaters is more than 12 hours.</p>	<p>Water is more than 3 feet above the first floor level of the building.</p> <p>The duration of the floodwaters is more than 12 hours.</p>

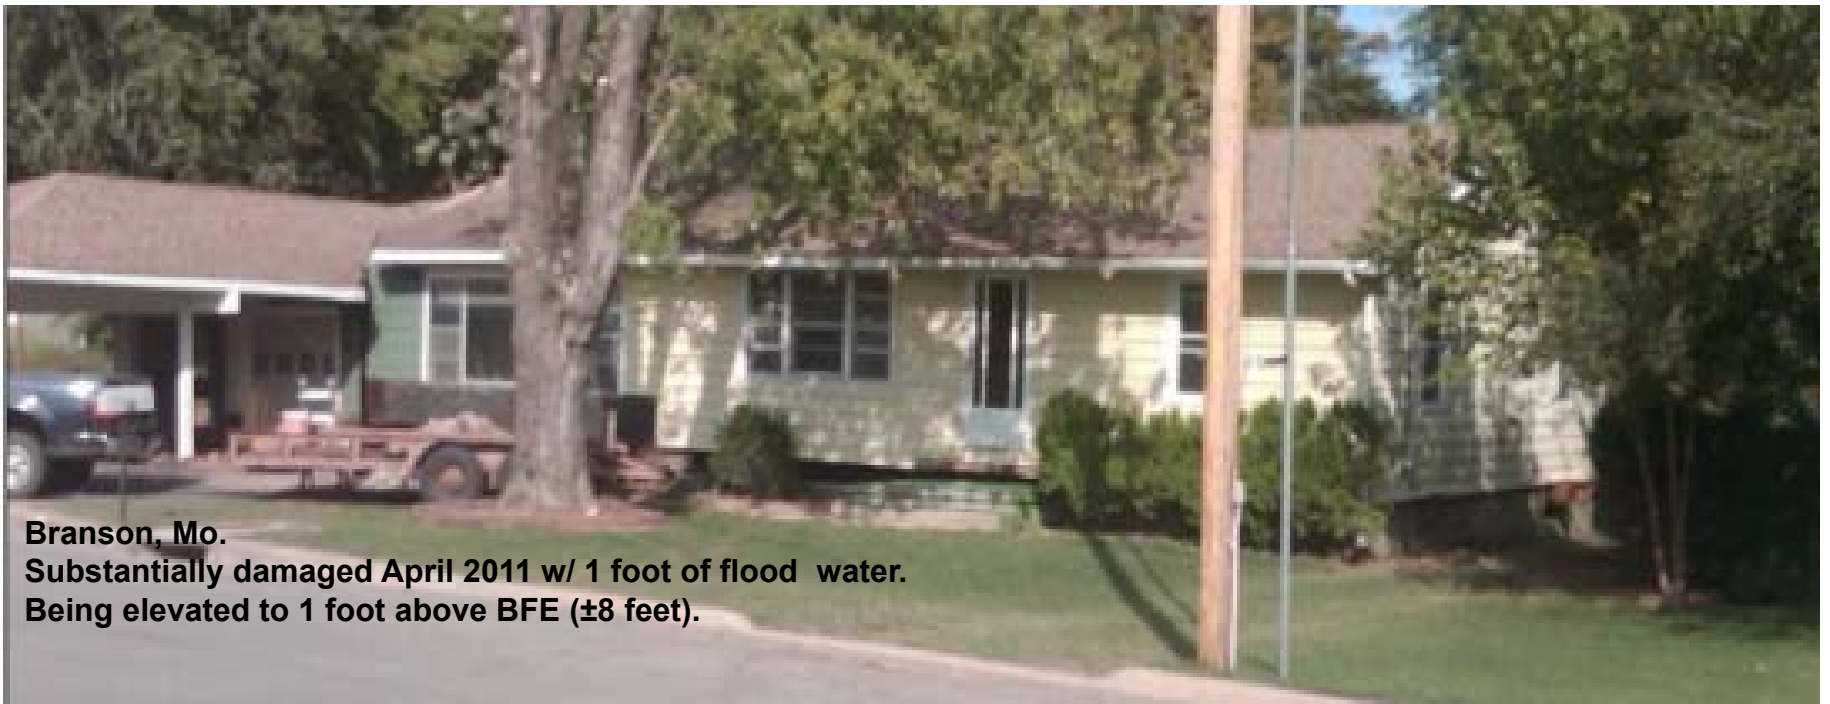
Branson, Mo.  
Substantially damaged April 2011 w/ 1 foot of flood water.  
Being elevated to 1 foot above BFE ( $\pm 8$  feet).

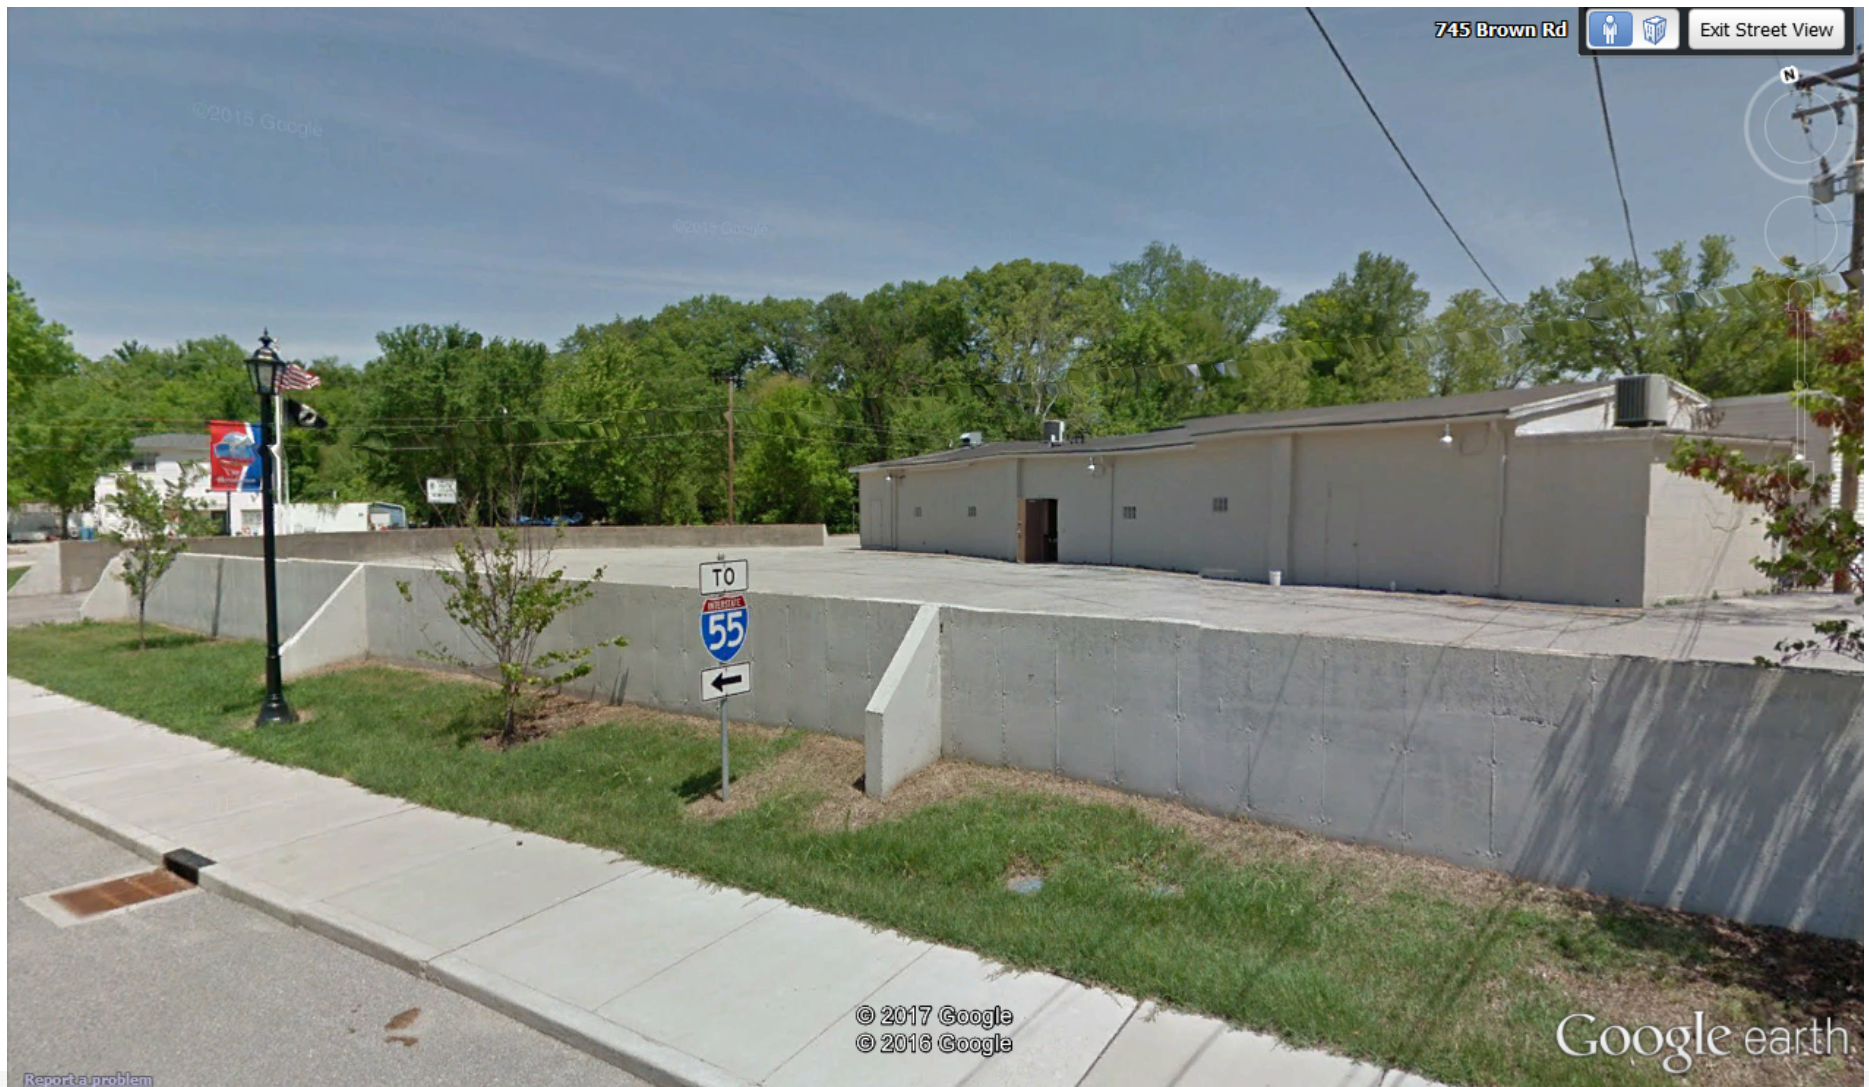
<b>Subdivision</b>		<b>Community</b>	
Subdivision	Elev. of Lowest Floor	NFIP Community Name	
Parcel # 0460711102002024000	830 ft.	NFIP Community ID #	
Lot Number	Datum NAVD88	Latitude 39.938453

<b>Building Address</b>	
Owner's Name	Duck, Dafy
Street Address	2009 W 104th Street
City	Leawood
County	Johnson
State	Kansas
Zip	66206
Phone	(999) 888-7777
Additional Owner(s)	N/A

<b>Building Information</b>	
Date of Construction	1985
Use	Commercial Retail
Quality	Average

<b>Damage Information</b>		<b>Structure Information</b>	
Date of Inspection	01/21/2016	Date of Damage	7/14/2015
Inspected by	Todd Tucker	Cause of Damage	Flood
Inspector Phone	(816) 283-7528	Duration of Flood	6 Hours
		Est. depth above lowest floor	2

# Non-Residential Assessment

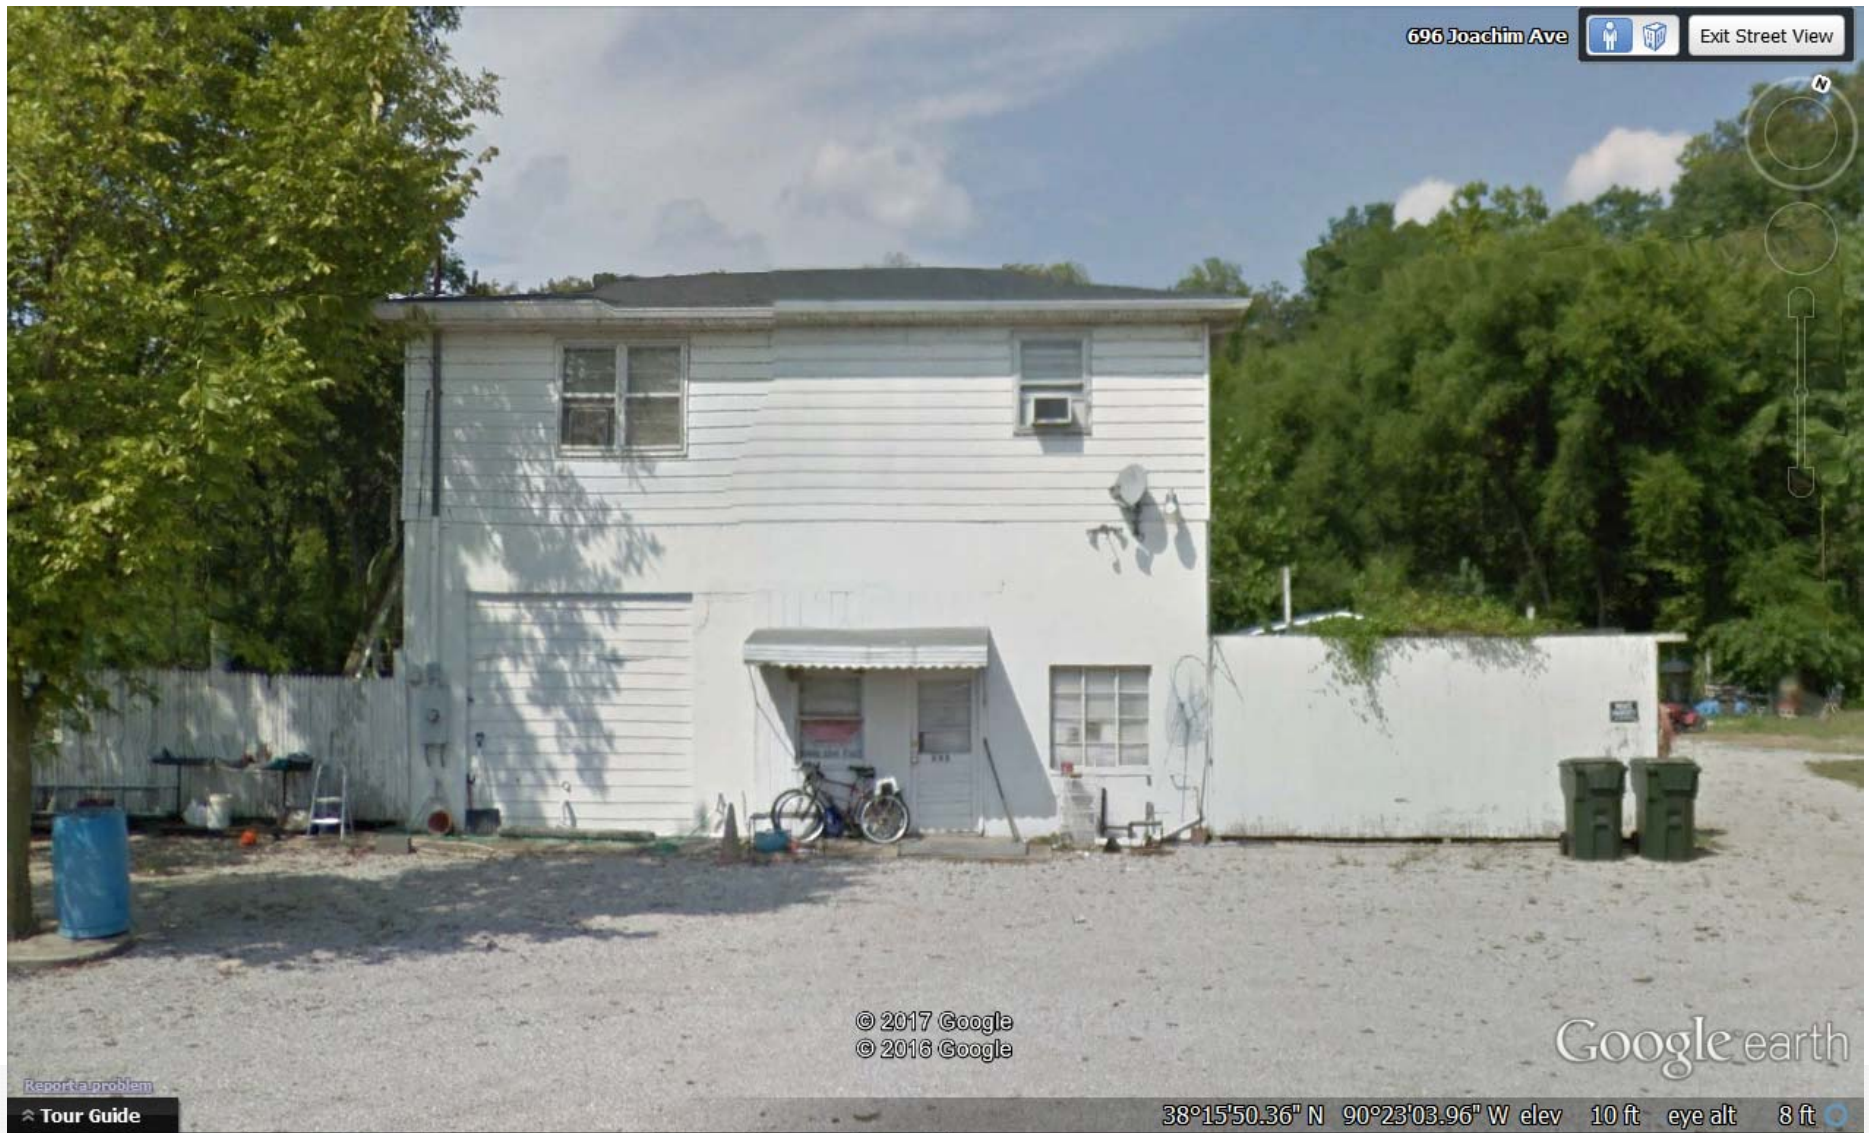
# Non-entry assessments

Exterior Finish		0- 25%	25-50%	50-75%	Over 75%
<p>The wall covering system that covers the wall sheathing, as well as insulation and weather stripping. This includes the water resistant materials and the finish materials: Stucco, Siding (aluminum, vinyl, or wood), Masonry, Stone veneer.</p> <p>Insulation is installed at the flooring beneath the lowest floor level and throughout the walls and ceilings. Types of insulation include: fiberglass wall and ceiling insulation, blown wall and ceiling insulation, and rigid wall insulation.</p>	<p><b>Threshold Markers</b></p>	<p>Water level is less than 6 inches above the lowest floor level.</p> <p>The duration of the floodwaters is limited - less than 12 hours.</p>	<p>Water level is between 6 and 18 inches above the lowest floor level.</p> <p>The duration of the floodwaters is limited - less than 12 hours.</p>	<p>Water level is between 18 inches and 3 feet above the lowest floor level.</p> <p>The duration of the floodwaters is more than 12 hours.</p>	<p>Water level is more than 3 feet above the lowest floor level.</p> <p>The duration of the floodwaters is more than 12 hours.</p>

<p>Water staining, contamination, and damages on some of the exterior wall finishes. 'Clean and repair' process is likely. Brick and stone veneer walls, stucco and 'cultured stone' may need some water removal techniques to allow drying of the interior walls and wall cavities. Adherence of the finish to the wall is required. A limited amount of siding materials may need replacement as required.</p> <p>No damage or</p>	<p>Damages/losses to some areas of the exterior wall surfaces, in addition to water staining and contamination. Some repairs are required at damaged locations prior or during 'clean and repair' process. Brick and stone veneer walls, stucco walls, and 'cultured stone' walls may need some water removal techniques to allow drying of the interior materials and wall cavities. Verify adherence of the finish materials to the wall substrate. Damaged house</p>	<p>Damages/losses to significant sections of the exterior wall surfaces, in addition to water staining and contamination. Significant repairs are required at damaged locations prior to 'clean and repair' process. Replacement of some sections of the exterior siding is required. Brick and stone veneer walls, stucco walls, and 'cultured stone' walls may need some water removal techniques to allow drying of the interior materials and wall cavities. Verify</p>	<p>Damages/losses to major sections of the exterior wall surfaces, in addition to water staining and contamination. Major repairs are required at damaged locations prior to 'clean and repair' process. Replacement of large sections of the exterior siding is required. Brick and stone veneer walls, stucco walls, and 'cultured stone' walls may need some water removal techniques to allow drying of the interior materials and wall cavities. Verify adherence of the finish</p>
